Contract #: 04-0120F4Cty: SF/ALA Rte: 80 PM: 13.2/13.9File #: 1.28**WELDING INSPECTION REPORT****Resident Engineer:** Casey, William**Address:** 333 Burma Road**City:** Oakland, CA 94607**Report No:** WIR-029893**Date Inspected:** 31-Jul-2013**Project Name:** SAS Superstructure**OSM Arrival Time:** 700**Prime Contractor:** American Bridge/Fluor Enterprises, a JV**OSM Departure Time:** 1730**Contractor:** American Bridge/Fluor Enterprises, a JV**Location:** Job Site**CWI Name:** Jesus Cayabyab**CWI Present:** Yes No**Inspected CWI report:** Yes No N/A**Rod Oven in Use:** Yes No N/A**Electrode to specification:** Yes No N/A**Weld Procedures Followed:** Yes No N/A**Qualified Welders:** Yes No N/A**Verified Joint Fit-up:** Yes No N/A**Approved Drawings:** Yes No N/A**Approved WPS:** Yes No N/A**Delayed / Cancelled:** Yes No N/A**Bridge No:** 34-0006**Component:** SAS Tower**Summary of Items Observed:**

WELDING INSPECTION REPORT

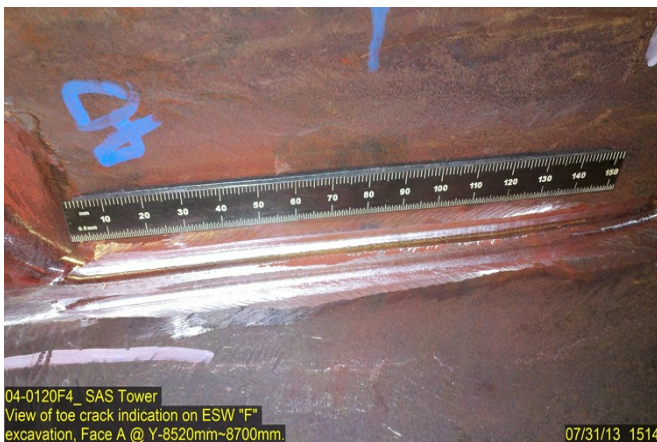
The QA Inspector was later present to observe ABF apprentice welder Simon Ma performing exploratory excavation of ESW "F" Face A @ Y-8790mm, 8960mm to verify indications observed during Ultrasonic Testing pulse/echo & pitch/catch. Mr. Ma was performing the excavation using a disc and bit grinder and was instructed by ABF QC Inspector Jesse Cayayab stated to halt at hold points and allow QC/QA to inspect the excavation.

Weld excavated at 28mm- Linear indication previously observed @8840 was removed.

Weld excavated at 28mm- Linear indication previously observed @8960 was removed.

Final excavation Length Y=8670mm~9090mm (420mm), Width-60mm, Depth-28mm.

After grinding to bright metal the QC Inspector performed MT testing of the excavation to inspect for weld discontinuities at each hold point. ON this date ABF production were instructed by ABF Field Engineer Eric Blue to excavate the 180mm long toe crack indication to a depth of 3mm that is located on the surface of the ESW weld F. The toe crack location is at @ 8520mm~8700mm. QA and QC performed MT testing on the toe crack repair and observed that the indication remained. The investigative information regarding the toe crack was passed along to ABF and CT METS representatives for additional review. The QA Inspector also informed Tower SMR Aaron Prchlik of the issue observed. See TL-6028 for additional details on items inspected on this date.
